Manhole Inspection Summary

Manhole # S27I__005MH

Insp Date: **5/30/08 10:49 AM**

Location Address: **924 W Lombard St**

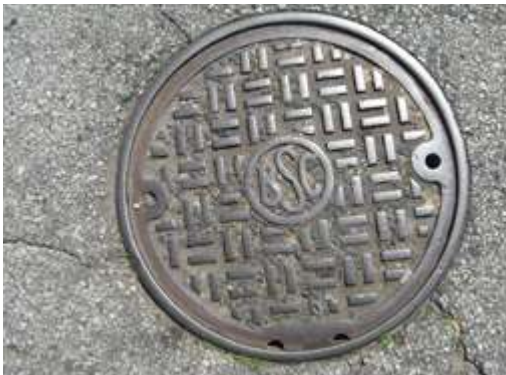
Cover View

Condition: **Sound**

Condition: ☐ Sound ☐ Cracked ☒ **Leaks**

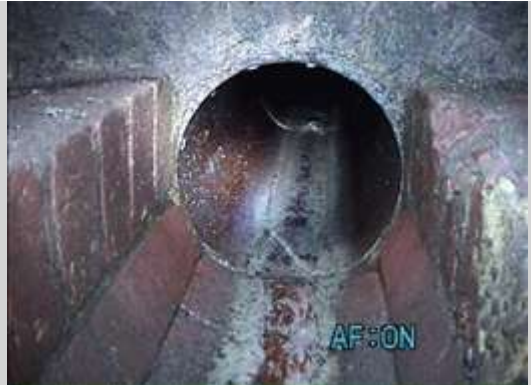
12 O'Clock Outflow

Pipe Height: **8.4** (in.) Rod and Bar (Angled)
Pipe Material: **Clay** ☐ Pipe Lined
Invert Depth: **9.77** (ft.) Flow Characteristics: **Fast**
Deposits: ☒ None ☐ Mud ☐ Sludge ☐ Debris ☐ Grease
Silt Depth: **0** (in.) Deposits Extent:
Infiltration: **None** Pipe Seal Cond: **Sound**

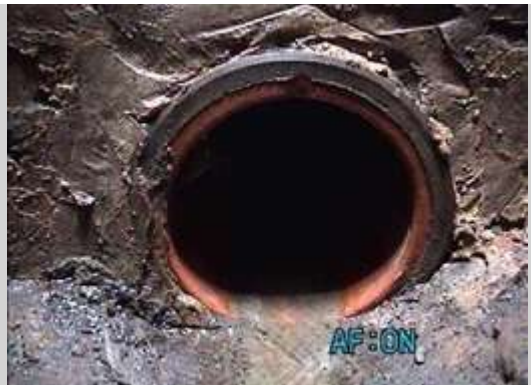
3 O'Clock Inflow

Pipe Height: **8.4** (in.) Rod and Bar (Angled)
Pipe Material: **Clay** ☐ Pipe Lined
Invert Depth: **9.33** (ft.) Flow Characteristics: **Fast**
Deposits: ☒ None ☐ Mud ☐ Sludge ☐ Debris ☐ Grease
Silt Depth: **0** (in.) Deposits Extent:
Infiltration: **None** Pipe Seal Cond: **Sound**

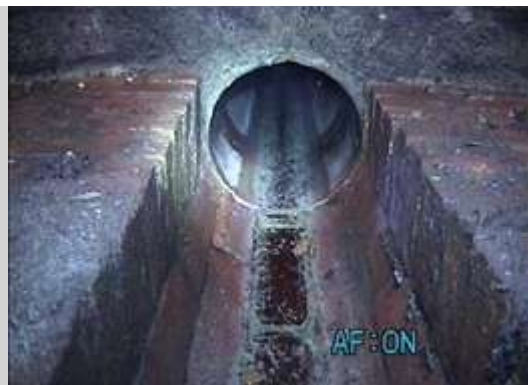
6 O'Clock Inflow

Infiltration: **None** Pipe Seal Cond: **Sound**
